THE HISTORIC VEGETATION OF FORT BIJ VECHTEN EXCURSION NOVEMBER 25TH, 2009

Nieuwe Hollandse Waterlinie (New Dutch Water Line)

The development of military vegetation on the Nieuwe Hollandse Waterlinie

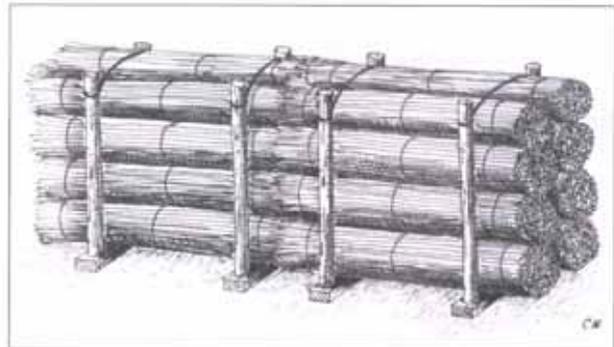
Figure 1 – Fascines

The vegetation had several purposes. First, hedges of and bushes of hawthorn (*Crataegus monogyna*) and blackthorn (*Prunus spinosa*) were used to create barriers. Also coppice of various tree species including pedunculate oak (*Quercus robur*), common ash (*Fraxinus excelsior*), black alder (*Alnus glutinosa*), sycamore (*Acer pseudoplatanus*) and white willow (*Salix alba*), functioned as a barrier. Because of the dense structure of the vegetation and the extensive rooting system, the coppice was also effective against hostile miners¹ and sappers². Trees (e.g. trees lining the dikes) were used to create abatisses³. Moreover, the branches and stems were used for fascines (figure 1) or the reinforcement of breastworks.

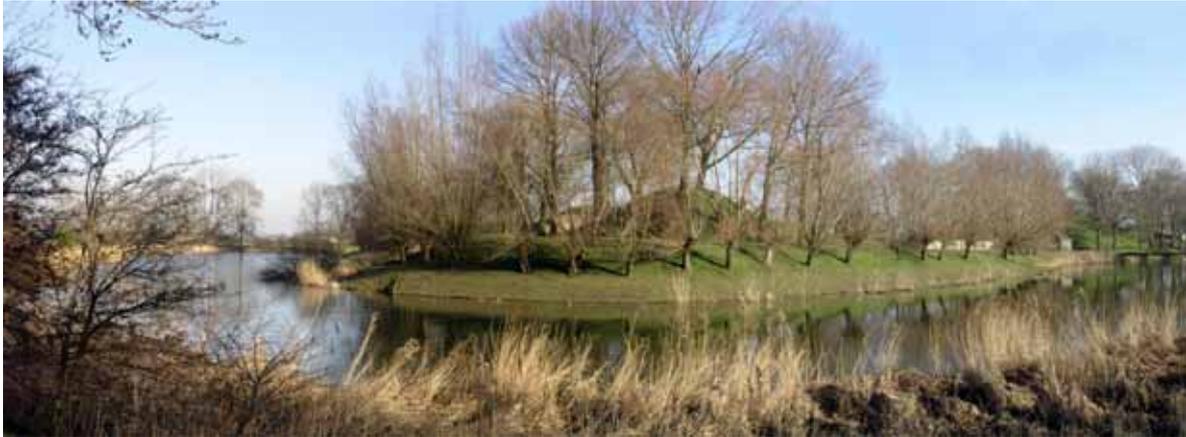
Figure 2 – Pollard willow of Fort Nieuwe Steeg. Pollard willow provided camouflage and cover.
 (Picture : Bureau SLA)

Second, trees and shrubs were used to provide camouflage and cover. For this purpose especially pollard willow was planted. The crowns of pollard willow created enough camouflage to conceal the guns on the fortification whereas the thin, flexible branches did not hinder the defensive fire from these guns. Also tree species like elm (*Ulmus spp.*), poplar (*Populus canescens*, *Populus x Canadensis*, *Populus spp.*) and Norway spruce (*Picea abies*) were used for camouflaging the fortifications in the landscape and providing cover and camouflage for the defenders on the fortifications.

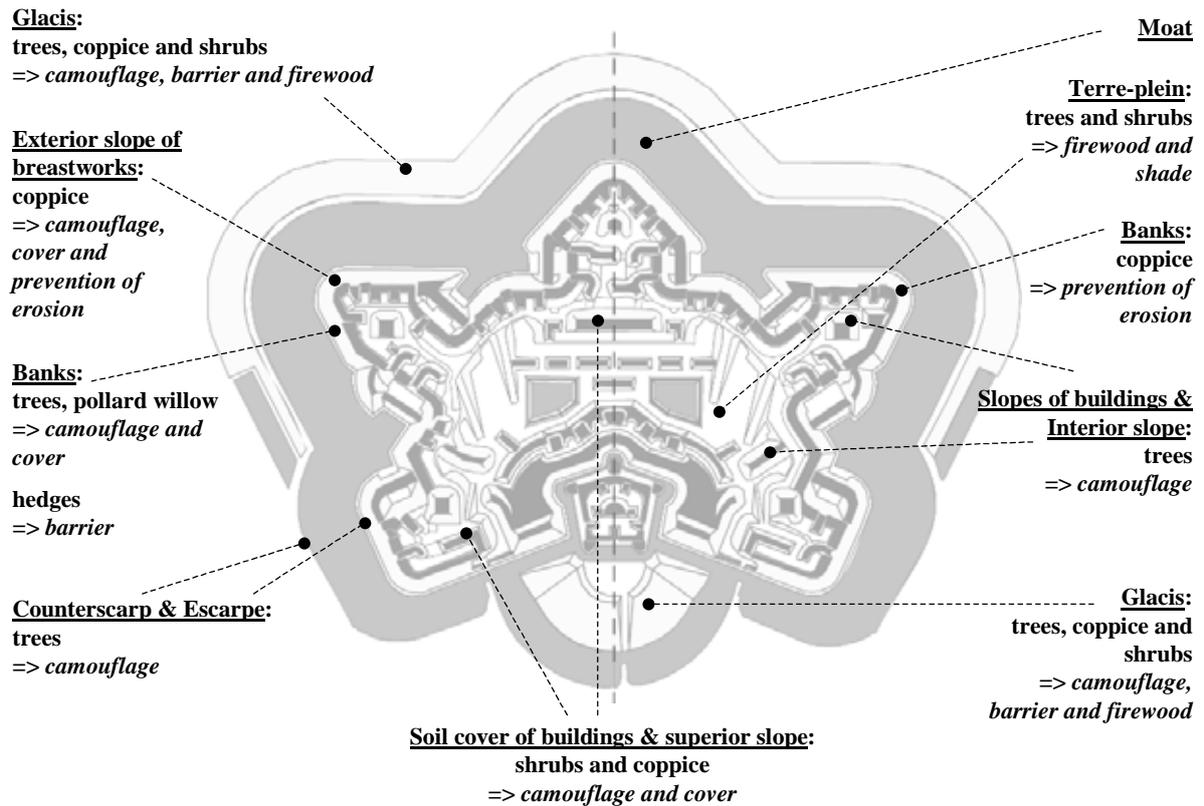
Figure 3 – Schematic overview of types and functions of military vegetation on the fortifications of the Nieuwe Hollandse Waterlinie

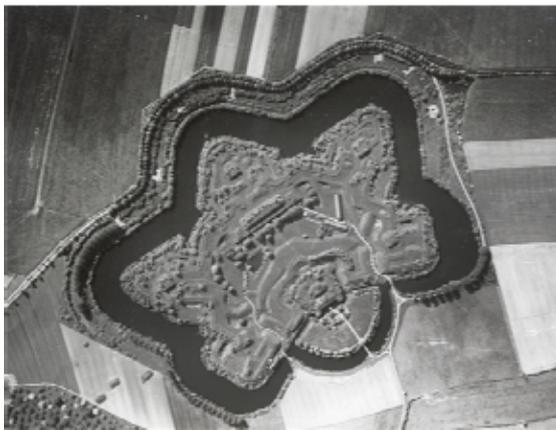
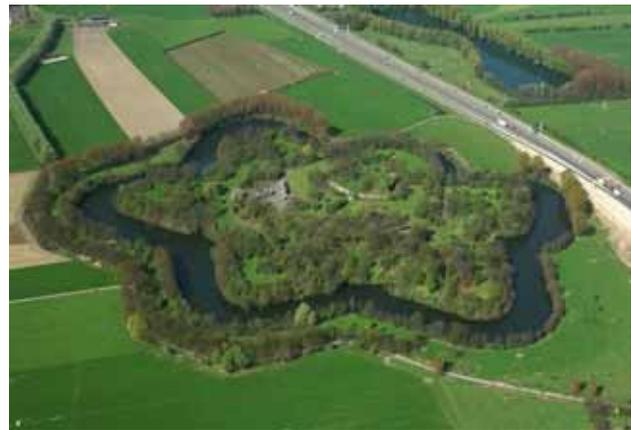
Figure 4 – Aerial photographs of Fort bij Vechten in 1926 (left) and 1997 (right)

Fort bij Vechten is a fortification of 17 ha. It was built between 1867 and 1870. Initially the fortress was covered with grass sods. Spots that were not suitable for applying sods were sown with ryegrass (*Lolium spp.*). In 1879 the War Office gave orders to establish defensive vegetation on the fortress. In 1880 specifications were made to plant 15 sycamore trees, 15 common horse chestnuts (*Aesculus hippocastanum*), 15 red oaks (*Quercus rubra*) and 15 lime trees (*Tilia spp.*) on the inside of the fortress (Terre-plein). On the banks 400 white willows and 8000 thorn-bushes for hedges were planted. The specifications also included the planting of 13.000 sycamore trees for coppicing and 50 elm trees on the glacis. The access road was planted with 250 oaks. In the next years 1892 and 1899 several specifications were made for the maintenance of this vegetation. These specifications show that in 1899 the fortress contained 2.2 hectares of coppice, 1250 meters of hedges, 13.114 metres of coppice on banks and slopes, 387 old trees and 165 young trees. An inventory made in 1909, showed that the defensive vegetation was still intact. However, aerial photographs taken in 1926 show that part of the defensive vegetation has been cleared, this was presumably done during the mobilization in World War I.
